M E M O R A N D U M

Re: **Metallurgical Evaluation of Two Piper Stabilator Horn Assemblies** (N7545P: PA 24-250, S/N 24-2752 and N5274P: PA 24-250, S/N 24-313)

Background

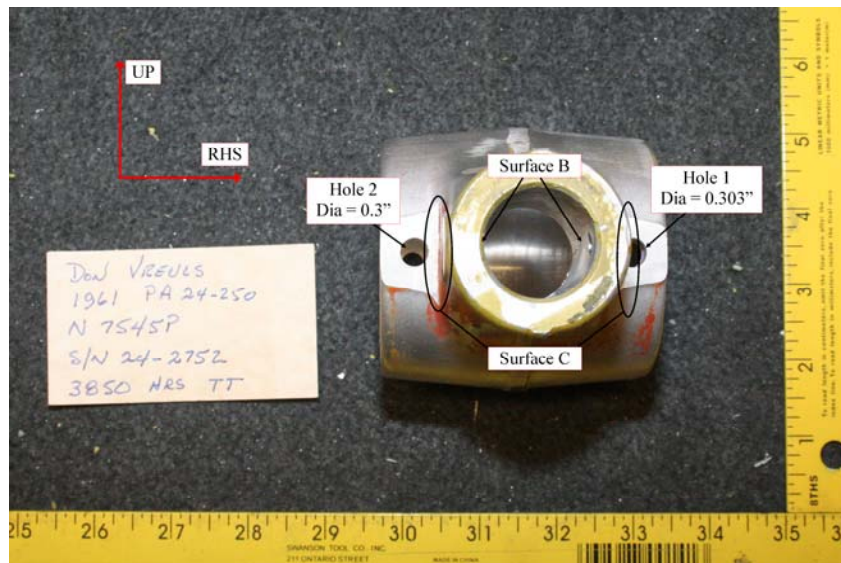
Figure 3 – Overview from A/C N7545P, Looking FWD

A second view of the same part is shown in Figure 3. The view is looking into the smaller 1.118 inch diameter bore in the fitting. The two 0.30 inch diameter fastener holes parallel to the small diameter bore are visible in Figure 3.

In the stabilator horn assembly a steel tube is press fit into the 1.118 inch diameter bore and held in place by a fastener through the tube and the 0.25 inch hole identified in Figure 4. The exterior paint on the part in Figure 4 and Figure 3 has mostly worn away but there were traces of green primer and remnants of orange paint.

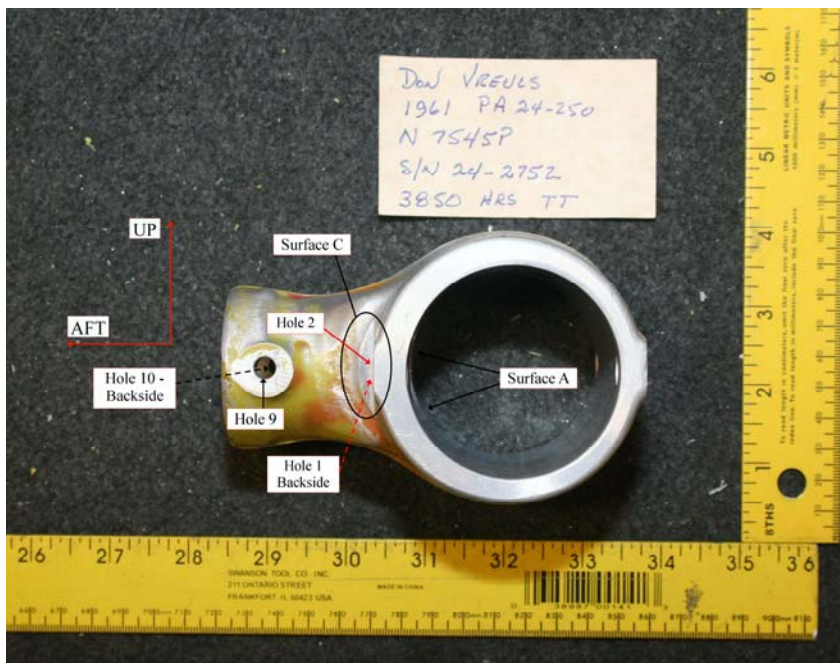
Figure 4 – Overview from A/C N7545P, Looking from the Side

The submitted stabilator horn fitting identified as A/C N7545P is shown in Figure 4. The view is looking into the large 2.312 inch diameter bore of the part. A 0.25 inch diameter hole parallel to the large diameter bore is also visible in Figure 4.

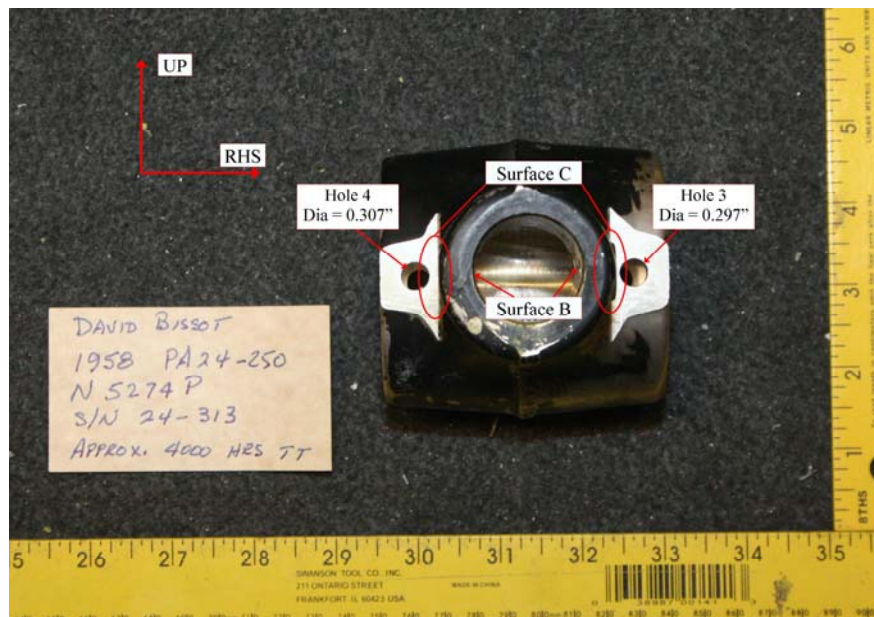
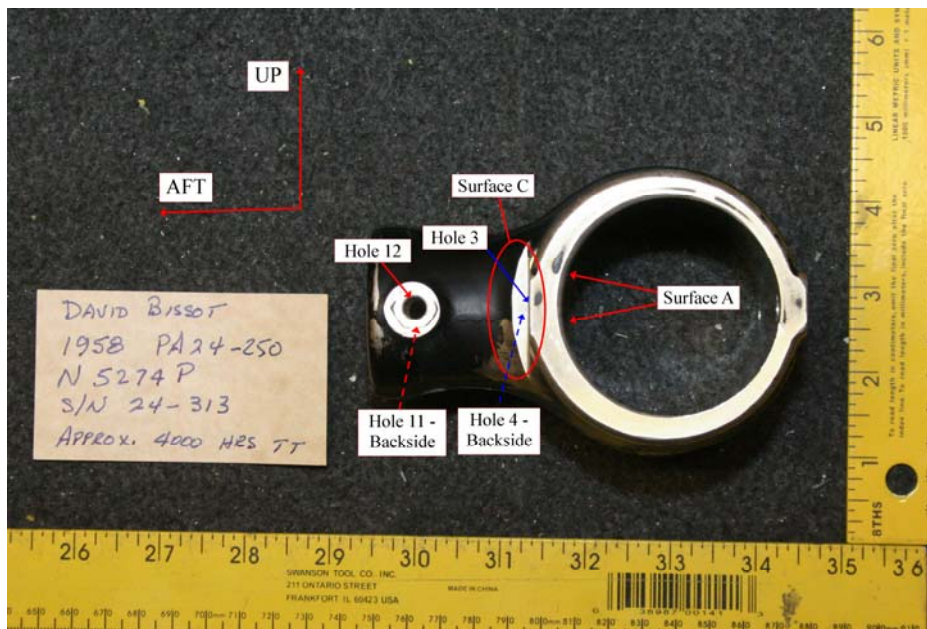
The second stabilator horn fitting (A/C N5274P) submitted is shown in Figure 7 and Figure 8. The views correspond to the similar views of the first part in Figure 3 and Figure 4. This part was painted black and the paint was still present on most of the exterior surfaces.

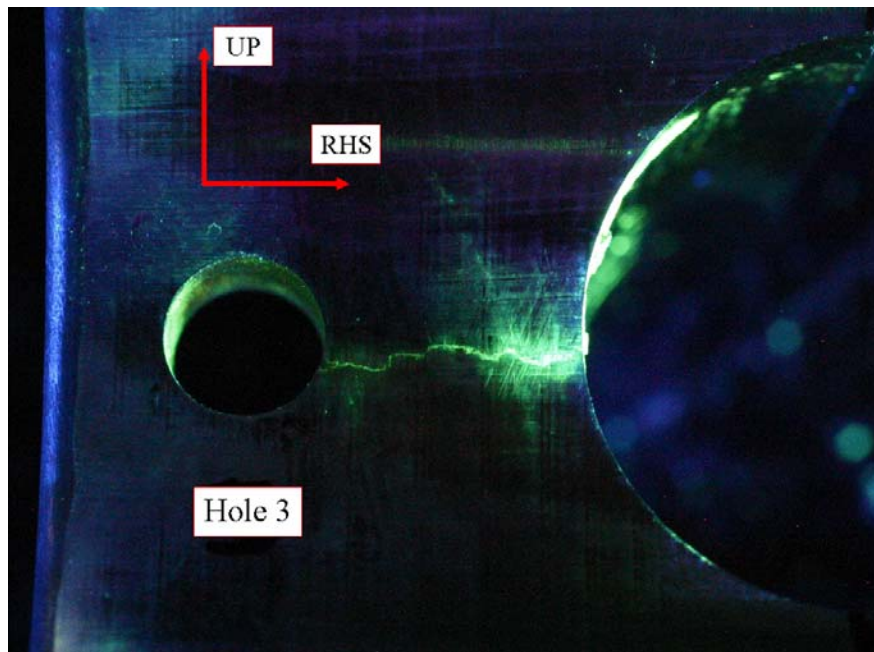
Figure 9 – FPI Hole 3 Crack, Surface A (A/C N5274P)

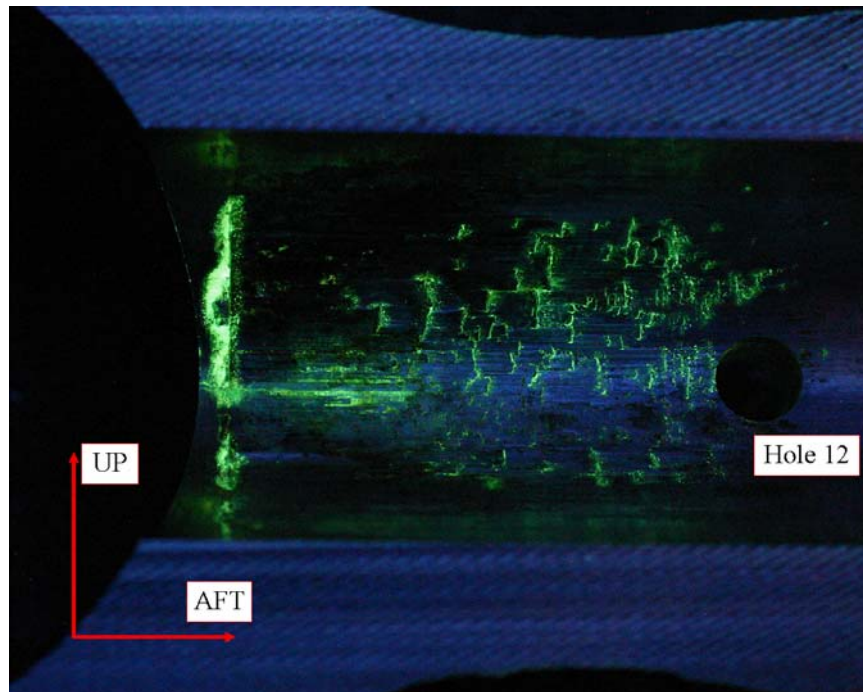
Figure 10 – FPI Hole 3 Crack, Surface B (A/C N5274P)

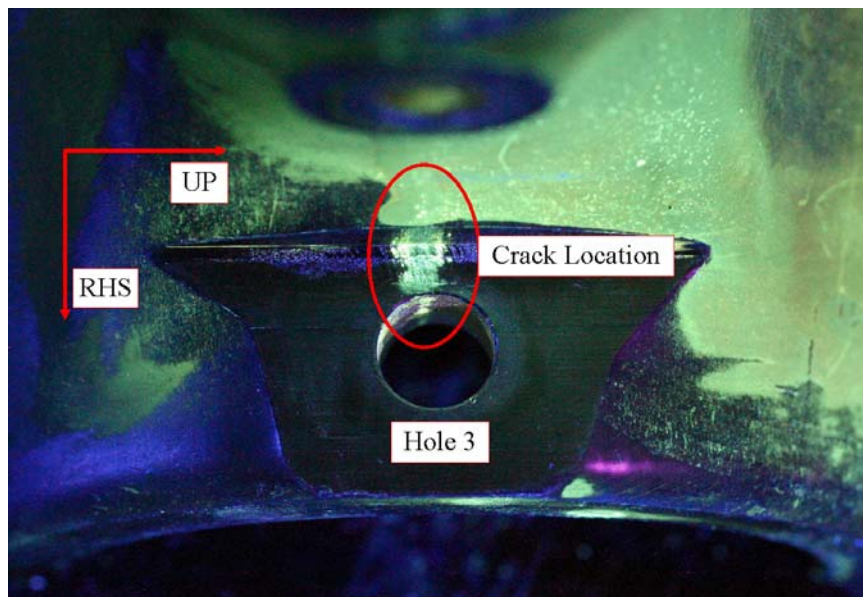
Figure 11 – FPI Hole 3 Crack, Surface C (A/C N5274P)

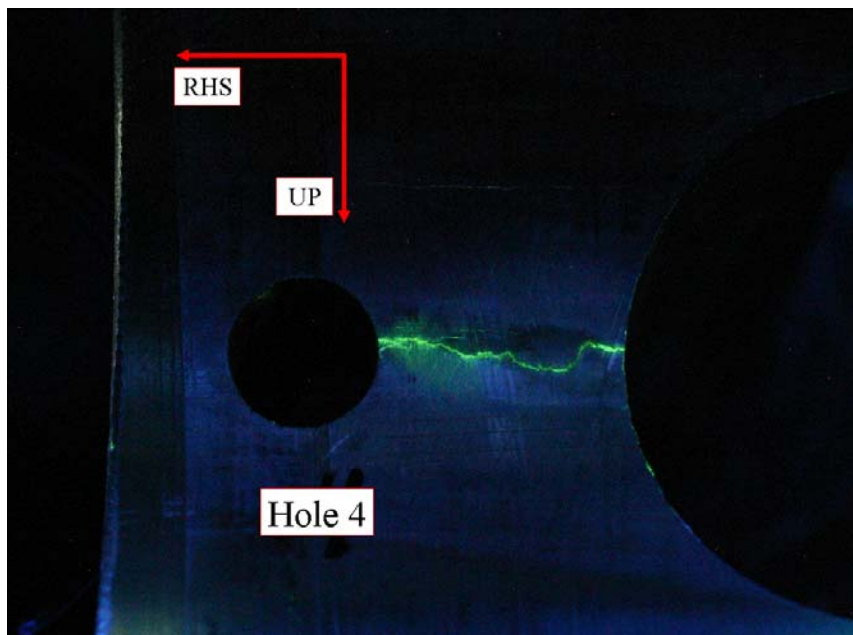
Figure 12 – FPI Hole 4 Crack, Surface A (A/C N5274P)

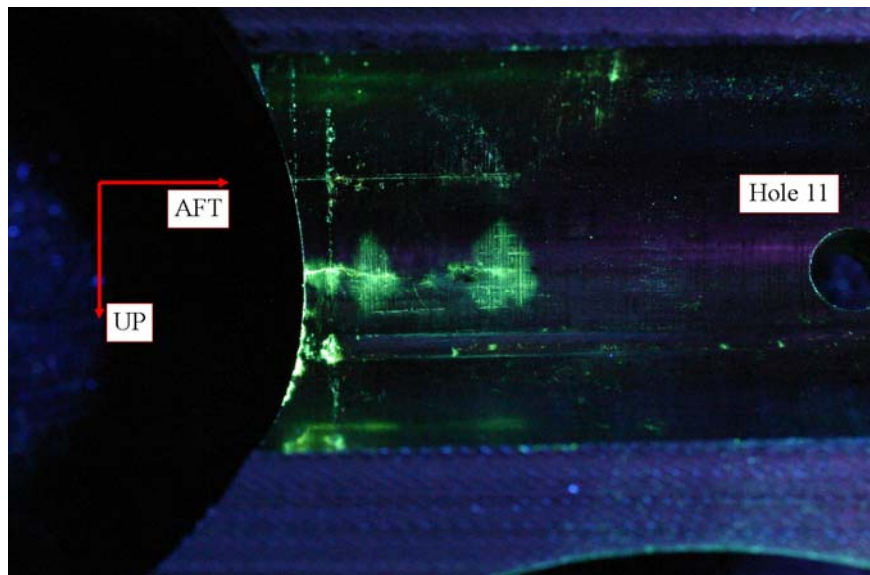
Figure 13 – FPI Hole 4 Crack, Surface B (A/C N5274P)

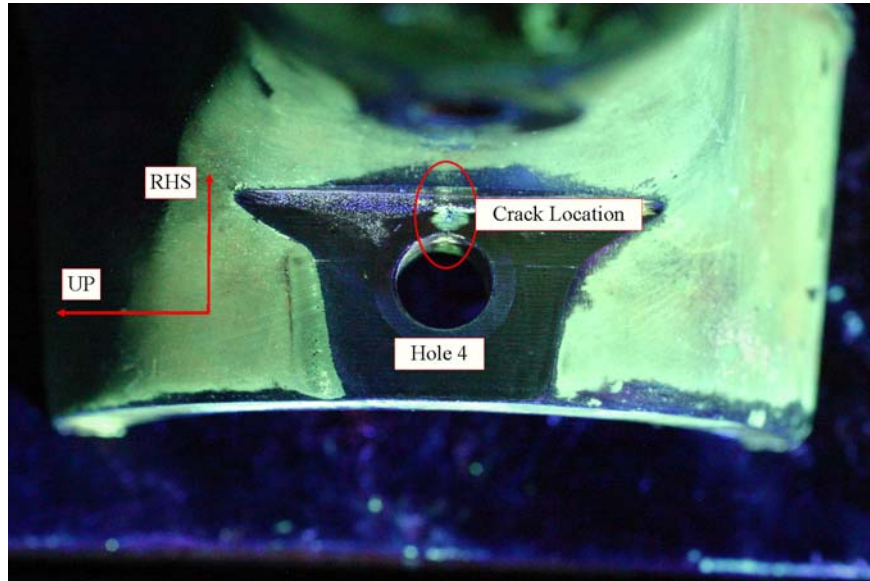
Figure 14 – FPI Hole 4 Crack, Surface C (A/C N5274P)

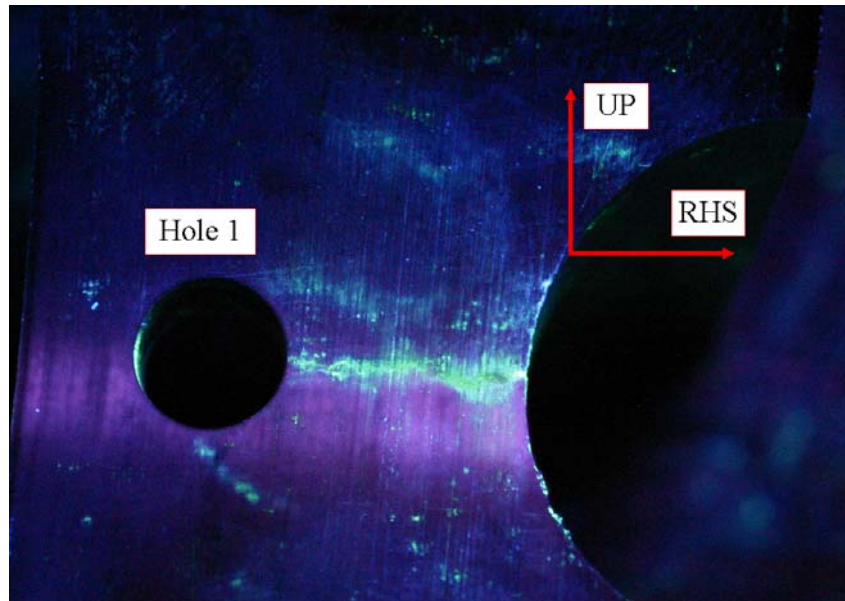
Figure 15 – FPI Hole 1 Crack, Surface A (A/C N7545P)

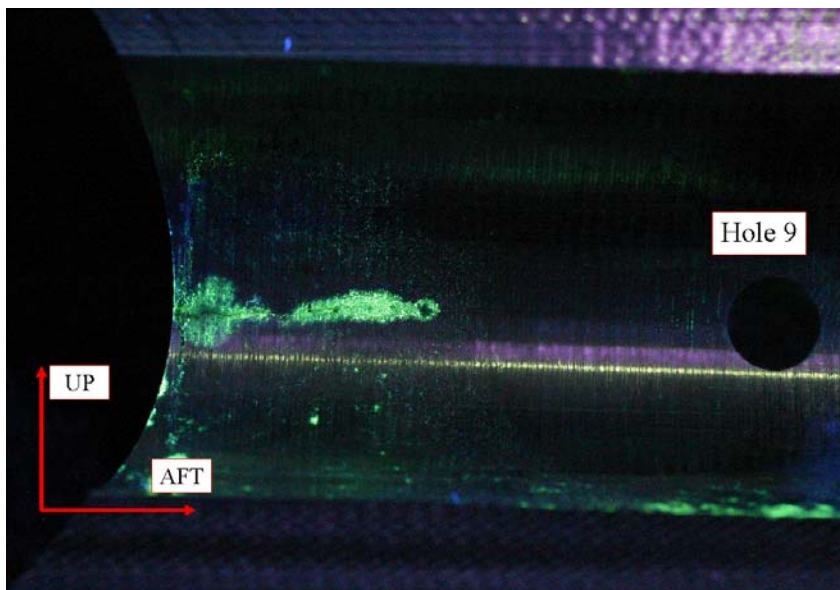
Figure 16 – FPI Hole 1 Crack, Surface B (A/C N7545P)

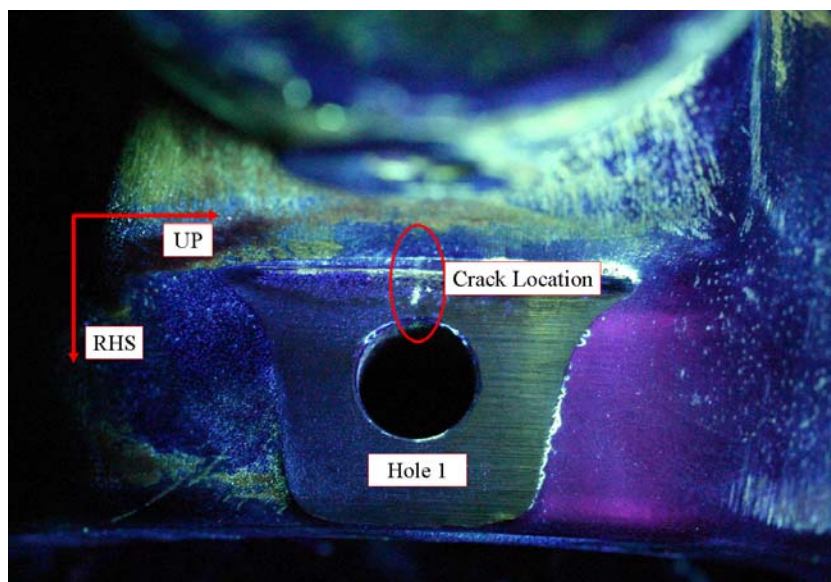
Figure 17 – FPI Hole 1 Crack, Surface C (A/C N7545P)

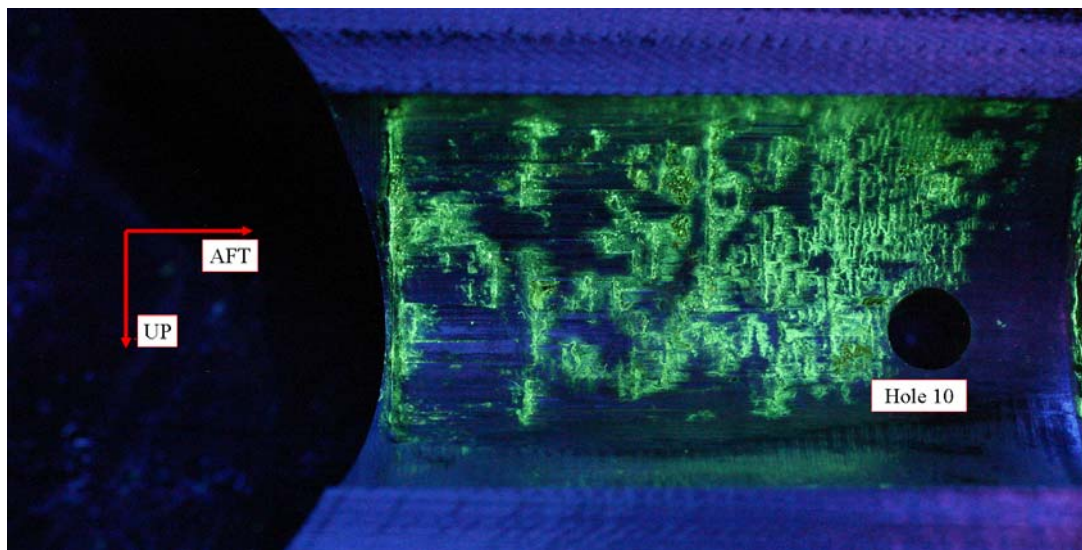
Figure 19 – FPI Hole 2, Surface B (A/C N7545P)

process and galling exists in the SB hole, the exposed grain boundaries provided nucleation origins for SCC. This partially adverse grain flow condition was a factor in the cracking. Hole 2 had the same evidence of grain flow and galling as shown in Figure 19, but did not show any evidence of cracking.

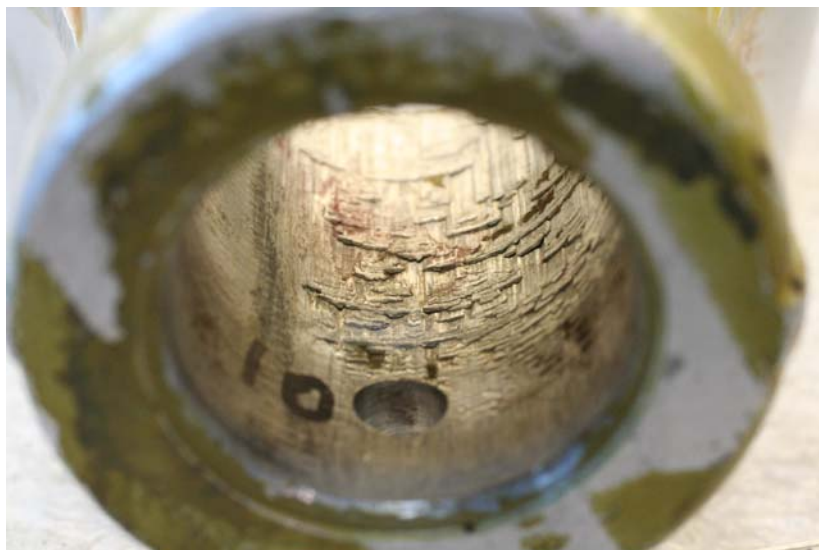
Figure 20 – Smeared Metal on Surface B from A/C N7545P

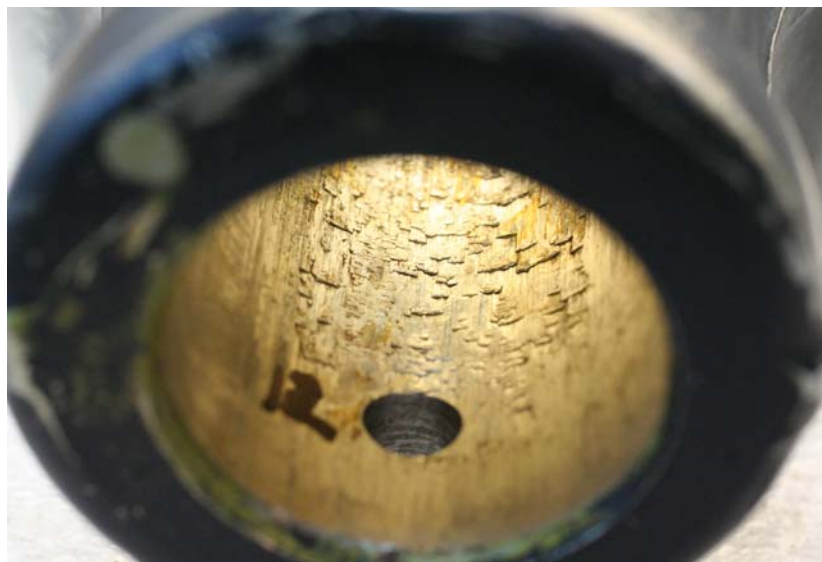
Figure 21 – Smeared Metal on Surface B from A/C N5274P

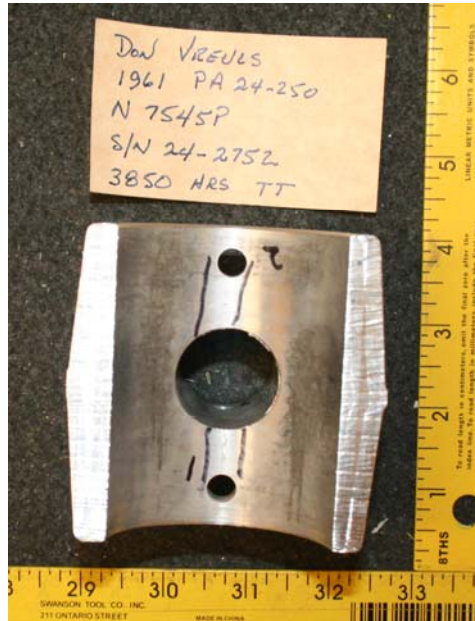
Figure 22 – Surface A of the Large Diameter Bore from A/C N7545P

and the 0.30 inch diameter fastener holes. The LB surfaces where crack indications were observed are shown in Figure 22 and Figure 23. Areas of interest are identified by Hole numbers 1 and 2 in Figure 22 and Hole numbers 3 and 4 in Figure 23.

Penetrant indications and visual cracks were observed in areas 1, 3 and 4 extending from the 1.118 inch diameter hole to the corresponding 0.30 inch diameter hole. No cracking was identified in or around Hole 2 on the part A/C N7545P by either visual or fluorescent penetrant inspection.

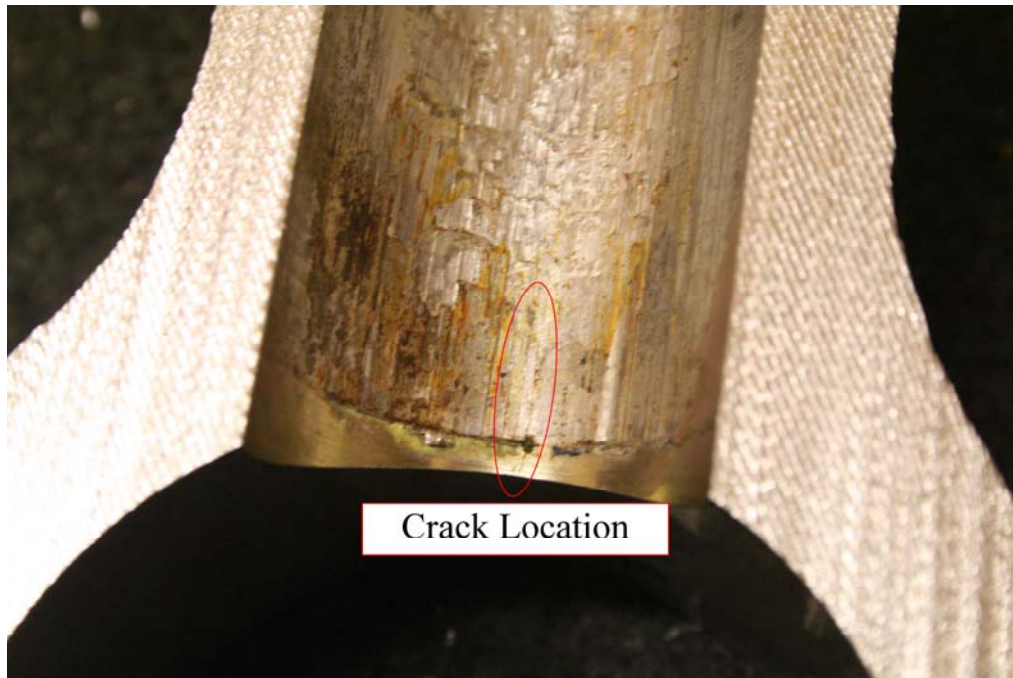
The three cracks observed (1 crack in N7545P and 2 cracks in N5274P) were also detected on the surface of the 1.118 inch diameter bore visually and with penetrant. The galling and smeared metal on the SB surfaces made it difficult to determine exact crack length either visually, with penetrant, or eddy current surface scanning. An example is shown in Figure 24. The cracking on Surface B, on A/C N5274P is visible at the intersection of the two larger bores but is difficult to detect on the rough surface of the smaller bore. There were also signs of rusting throughout the SB hole, due to the steel tube inserted during production.

Figure 24 – Cracking and Roughness on Surface B from A/C N5274P

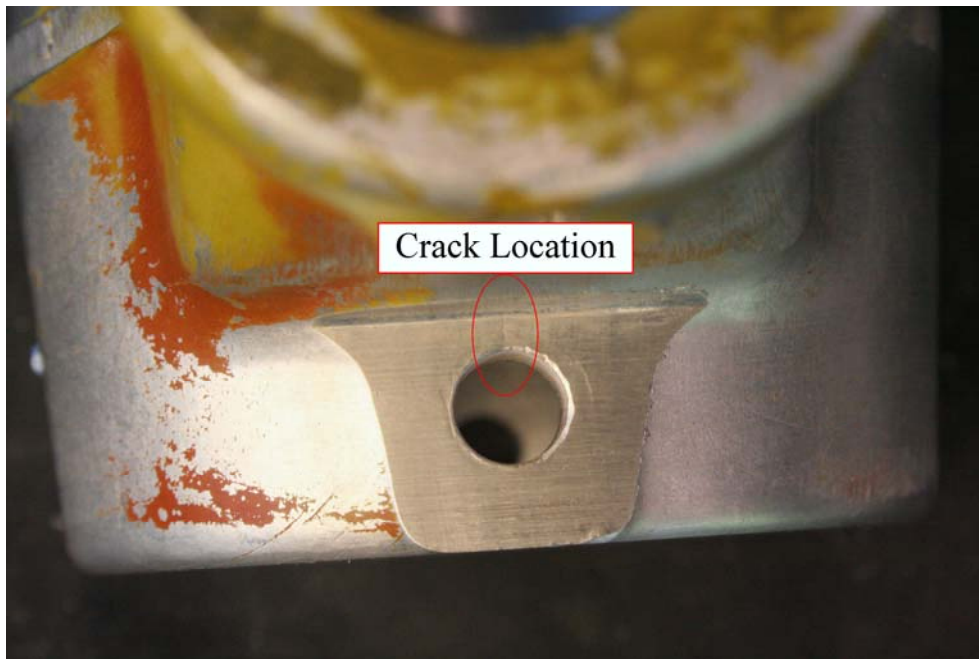
The three cracks all appeared to be at least 0.5 inch long on the small bore surface. All of the three cracks found were observed visually and with penetrant inspection on the part exterior surface at the edge of the 0.30 inch diameter fastener holes. A typical example (Hole 1 Crack from A/C N7545P) is shown in Figure 25.

Figure 25 – Hole 1 Crack Penetrating on Surface C, A/C N5274P

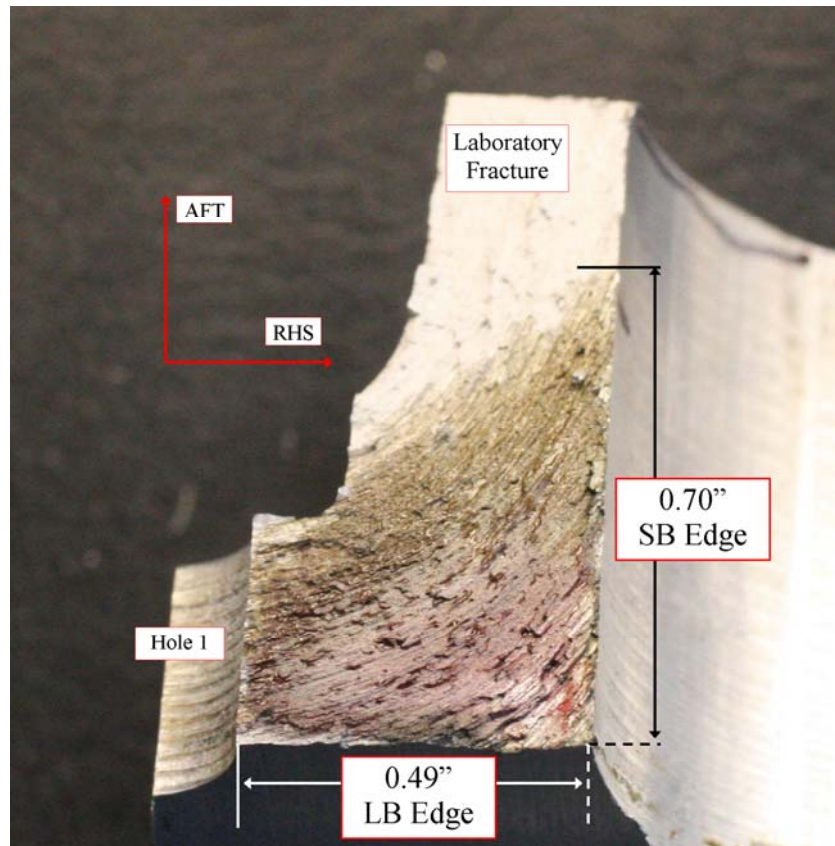
Examination of the faces of the opened cracks showed general features typical of stress corrosion cracking. The faces had a “woody” intergranular appearance and there was evidence of corrosion products on the faces. The face of the crack in Hole 1 from A/C N7545P is shown in Figure 26. The face was covered with corrosion products and had a reddish tint which may have been remnants from a previous dye penetrant inspection. Solvent cleaning of the face removed the reddish color but much of the other material remained on the face. The dimensions of the cracking along the two bore surfaces are indicated in Figure 26.

Figure 26 – Face of Hole 1 Crack from A/C N7545P

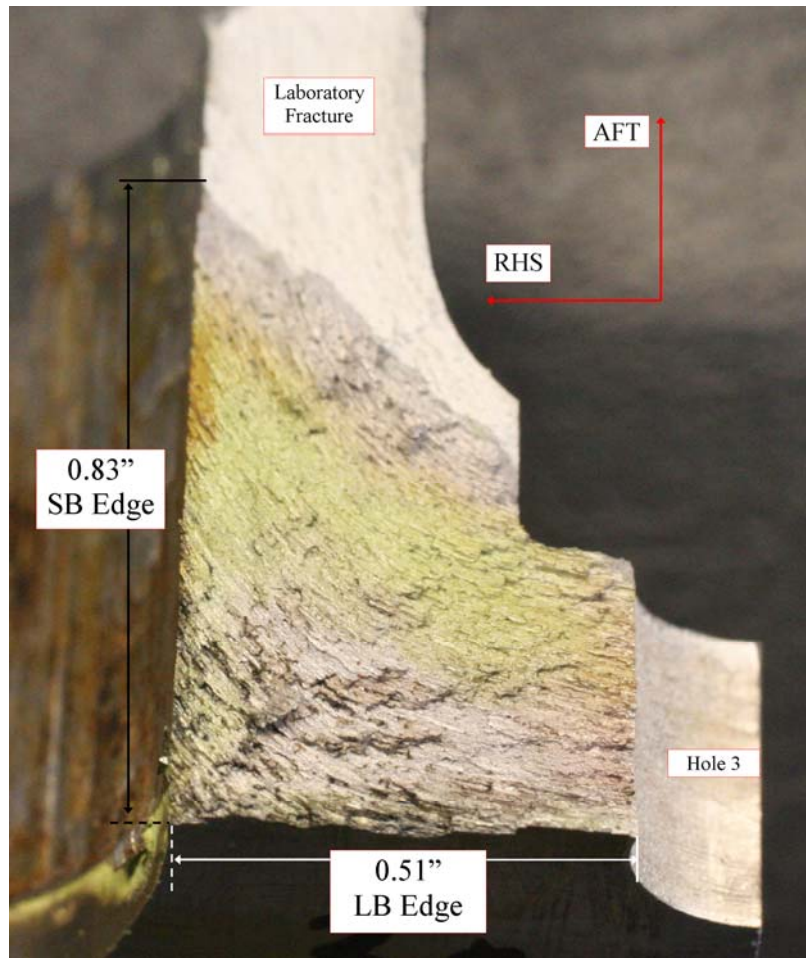
The face of the crack detected in Hole 3 of the part from A/C N5274P is shown in Figure 27. The green color on the face is fluorescent penetrant remnants which were removed with solvent cleaning. The SB surface exhibited rough areas with a rust color. There also were local areas on the crack face along the edge of the SB with a rust color. Maximum dimensions of cracking along the two bores are indicated.

Figure 27 – Face of Hole 3 Crack from A/C N5274P

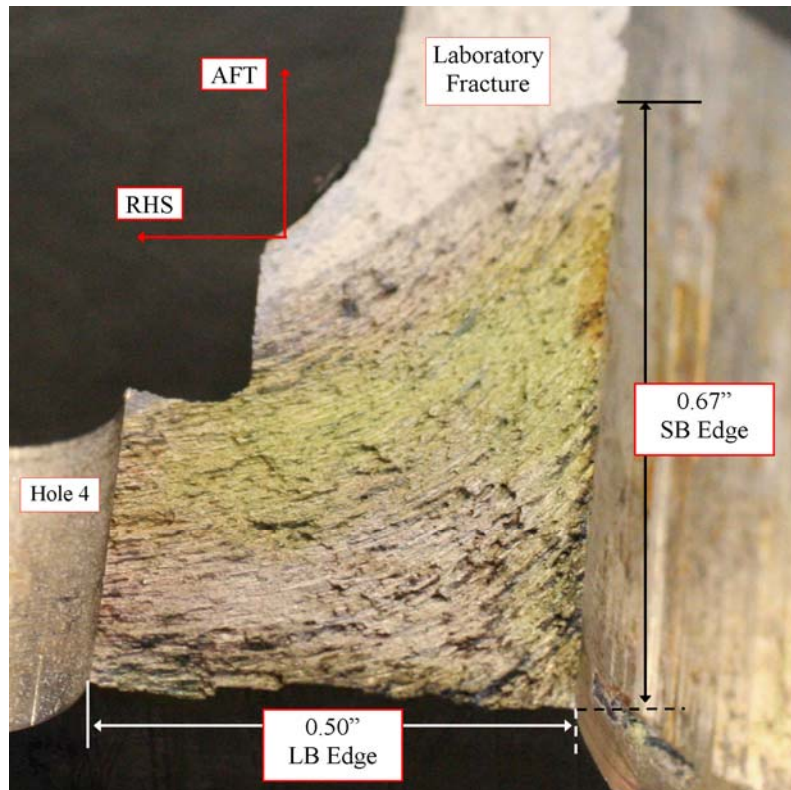
The face of the crack detected in Hole 4 of the part from A/C N5274P is shown in Figure 28. The face has been solvent cleaned, but there are still areas with a rust color along the edge of the SB hole.

Figure 28 – Face of Hole 4 Crack from A/C N5274P

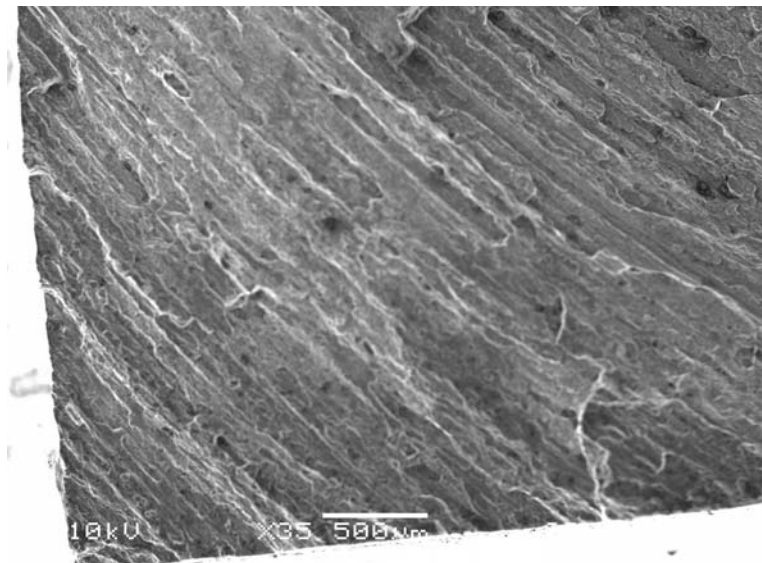
Higher magnification examination of the crack faces confirmed that cracking was due to stress corrosion. The cracking was intergranular and followed the grain flow of the part. There was evidence of corrosion scale that had not been removed by cleaning the crack faces. On each of the crack faces there was pronounced grain flow across the corner formed by the intersection of the two bores. The features at the corner of the faces of the crack are shown in Figure 29.

Figure 29 – Corner of Crack Face from A/C N7545P

The grain flow characteristics in the two figures showed that the machining of the two bores had caused an end grain condition to be at least partially exposed to both machined surfaces near the intersection. Since the grain flow runs approximately at a 45 degree angle in Figure 30 due to the forging

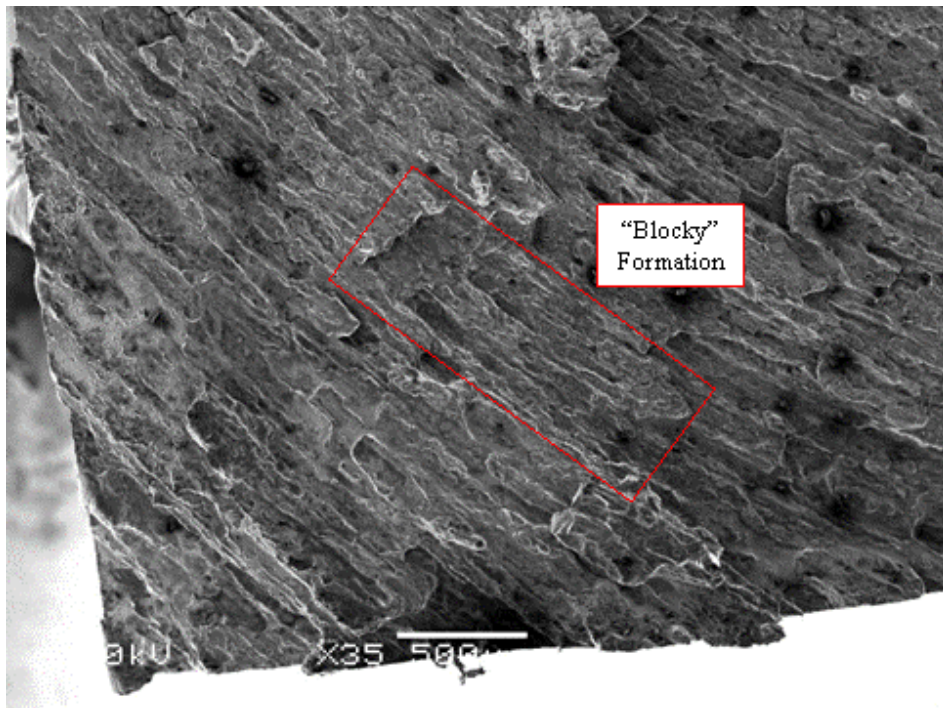
The corresponding features at the corner of the crack face at Hole 3 of A/C N5274P are shown in Figure 30.

Figure 30 – Corner of the Crack Face, Hole 3 from A/C N5274P

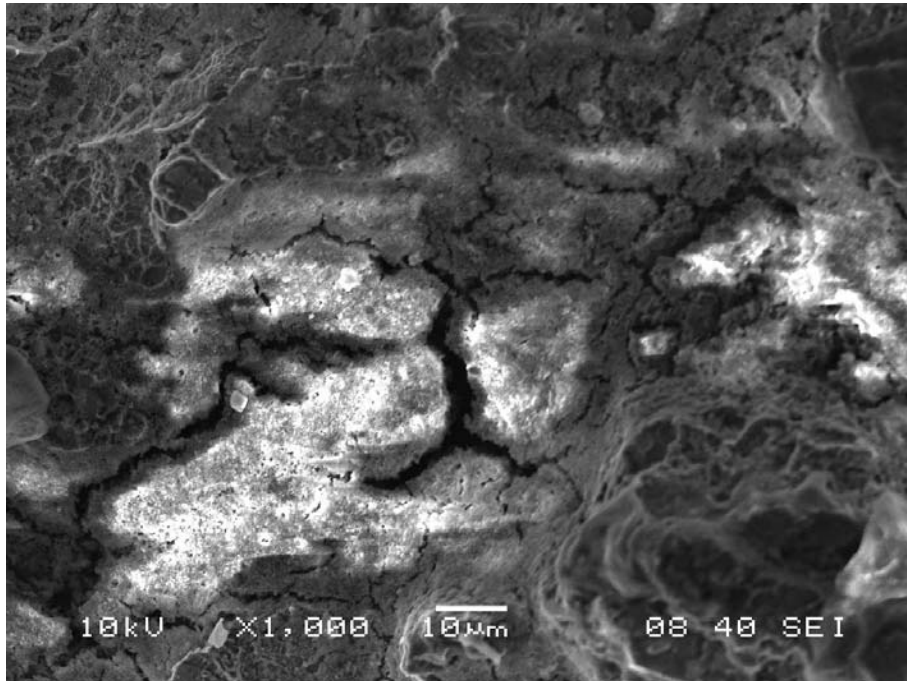
An electron fractograph of typical crack faces features at higher magnification is shown in Figure 31. A “blocky” looking region had intergranular features and some evidence of corrosion products on the surfaces shown in the fractograph. The area shown was located a short distance from the corner of the face of the crack, part A/C N7545P.

Figure 31 – Electron Fractograph of Intergranular Crack Face from A/C N7545P

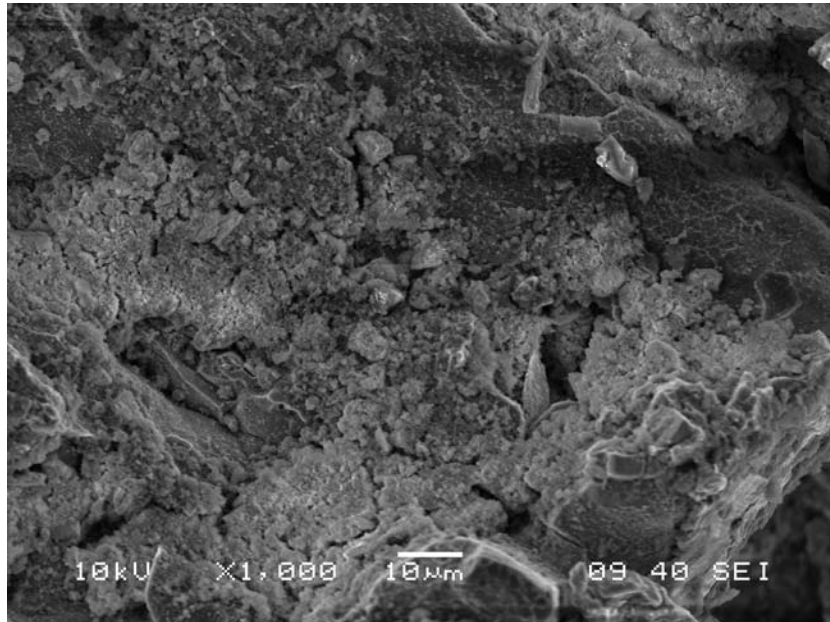
Another area with the stress corrosion cracking features is shown in Figure 32. There is a general block looking intergranular appearance with evidence of a heavy corrosion scale. There is an appearance of “mud cracking” in the scaled areas where there is a characteristic of stress corrosion cracking. The area shown was located a short distance from the corner of Hole 3 crack face shown in Figure 27.

Figure 32 – Intergranular Features with a Corrosion Scale from A/C N5274P

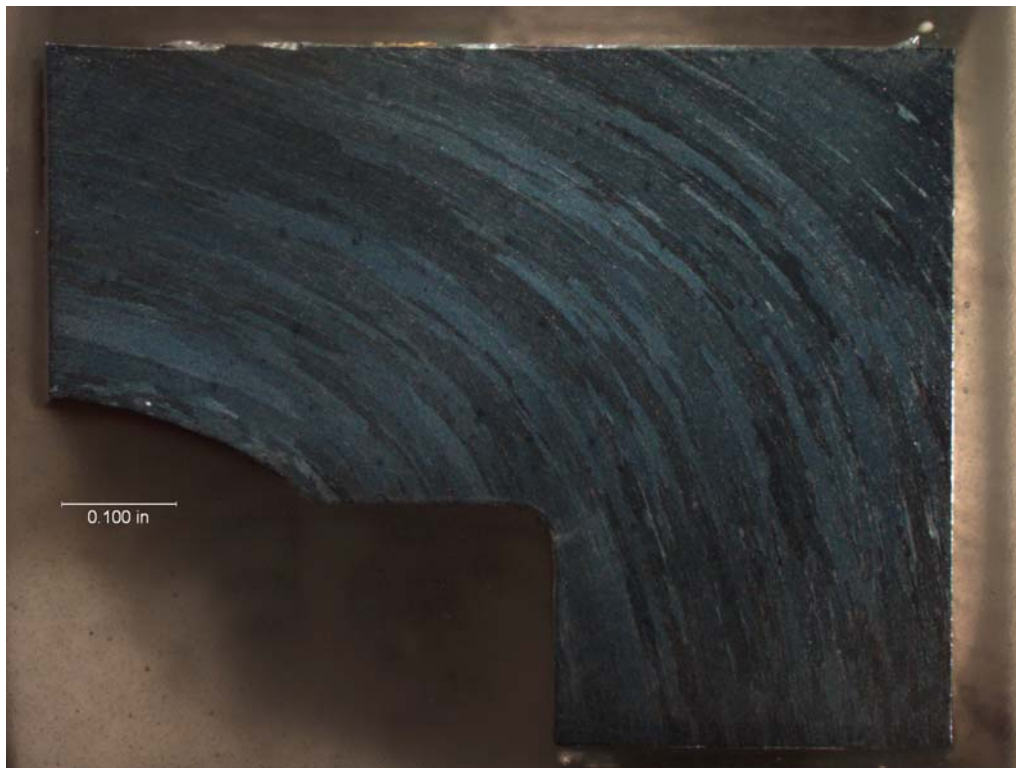
The metallographic cross section was taken in the area identified as Hole 2 in Figure 22. The cross section was in the same plane as the plane of cracking at the other three locations. The overall grain flow in this region corresponded well to the “flow” observed on the crack faces. The overall grain flow is shown in Figure 33. The observed pattern confirmed that there was at least partial exposure to an end grain condition on both bore surfaces near the corner.

Figure 33 – Grain Flow Pattern from A/C N7545P

The rough surface along the small diameter bore is visible at the top in Figure 33. The grain size in Figure 33 appears to be relatively large but part of that may be due to the short transverse grain direction being perpendicular to the plane of observation. Figure 33 shows grain flow near hole 2, the non-cracked location. Figure 26 through Figure 28 show the same grain flow characteristics as expressed in Figure 33.

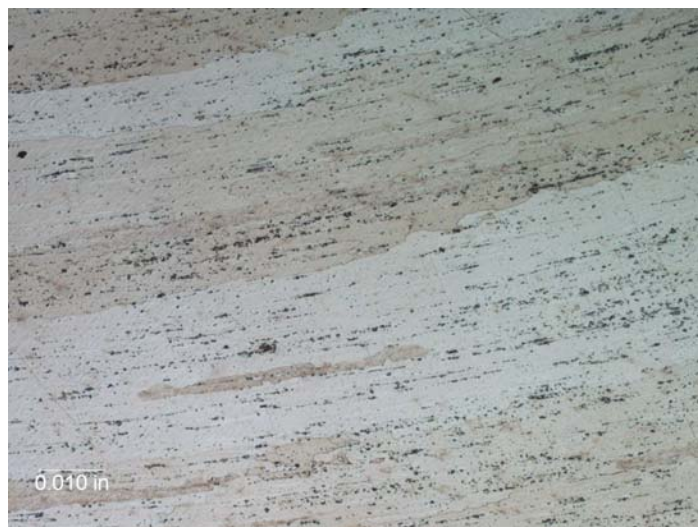
The typical material microstructure on the cross section is shown in Figure 34. The area shown was a short distance from the intersection of the two bores in the part. The microstructure was typical for 2014 aluminum forgings.

Figure 34 – Typical Material Microstructure
