Comanche Stabilator Horn Cracking Investigation

Final Analysis Report

International Comanche Society

March 29, 2011

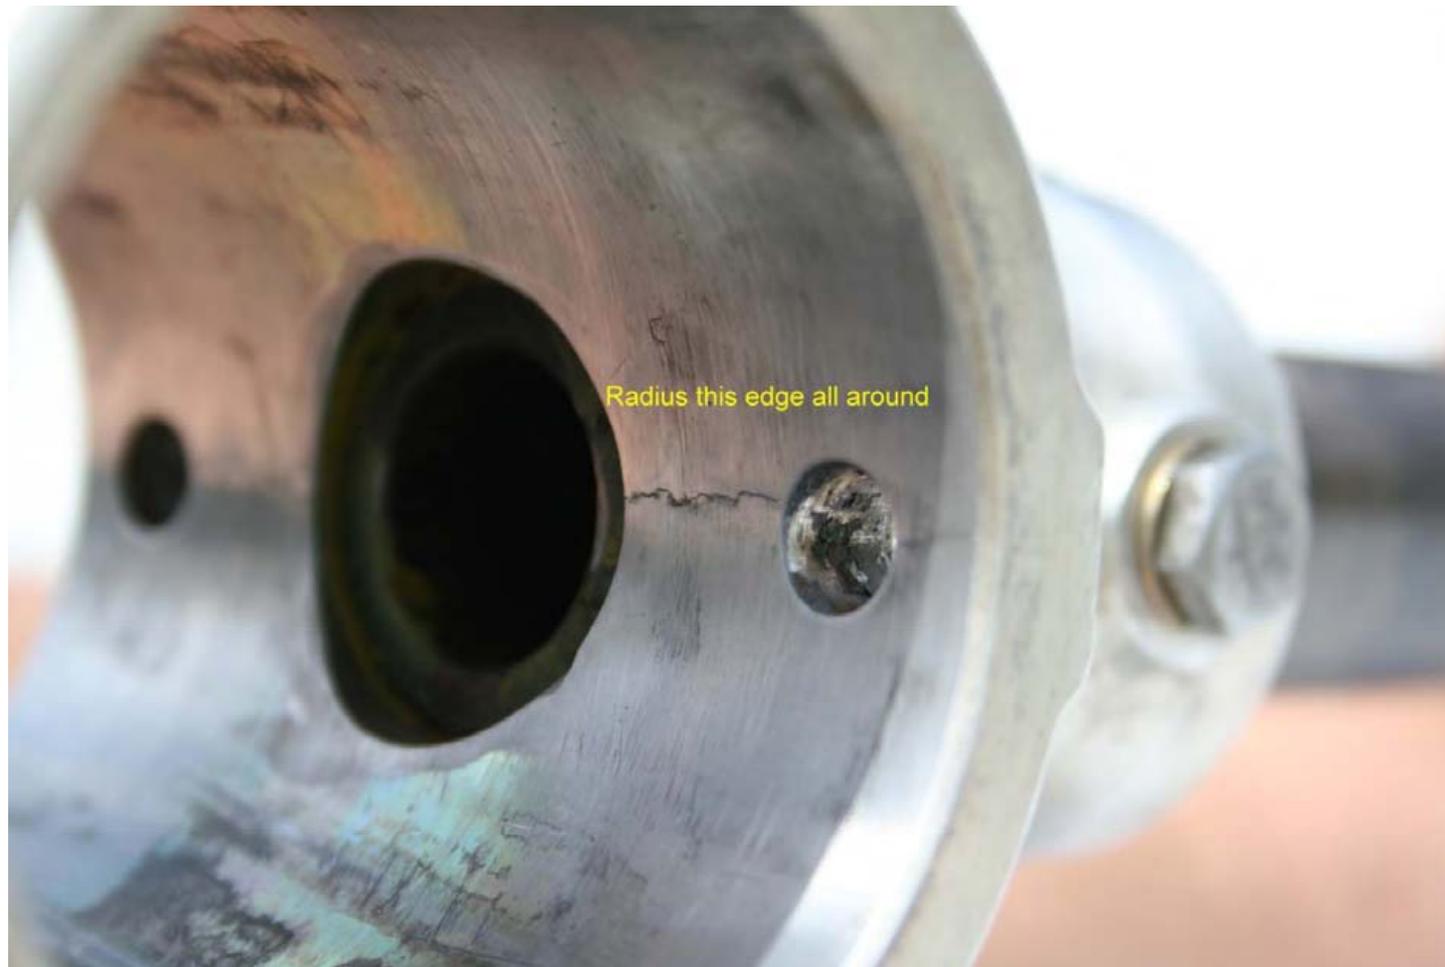
Typical Cracked Horn

FAA performs metallurgical investigation at NIAR, stress corrosion cracking determined as primary cause (ref. NIAR Memorandum dated 31 Aug 2009)
