M E M O R A N D U M

Re: **Metallurgical Evaluation of Two Piper Stabilator Horn Assemblies** (N7545P: PA 24-250, S/N 24-2752 and N5274P: PA 24-250, S/N 24-313)

Background

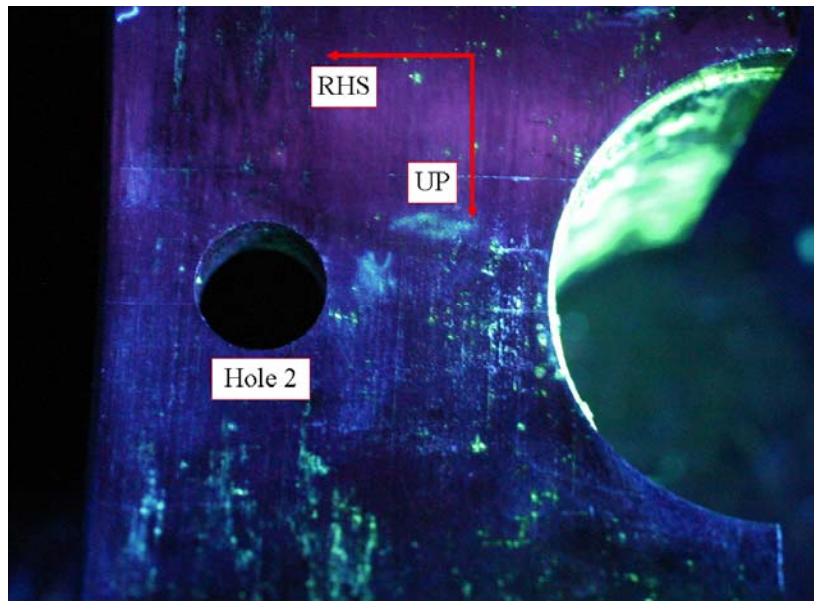
The two submitted parts were visually examined and photographed to show the as-received part condition pictured in Figure 1 through Figure 8. NIAR examiners did not visually find any lot markings, manufacturing logos, etc on the exterior or interior of the parts. Preexisting exterior damage/surface scratches prior to part disassembly are shown in Figure 2 and Figure 3. The diameters of the fastener holes and the large bores in the two parts were measured and compared to engineering drawings. The two parts were then subjected to a fluorescent penetrant inspection to determine the location and approximate extents of the cracking. Figure 9 to Figure 17 show the cracks prior to cutting the horn assemblies. These figures also identify the naming process for surfaces; Surface A interior LB hole surface (Figure 4 and Figure 8), Surface B interior SB hole surface (Figure 3 and Figure 7), and Surface C is the exterior location (Figure 3 and Figure 7). Figure 18 and Figure 19 show the fluorescent penetrant inspection (FPI) results for Hole 2 (A/C N7545P). This suspected crack location was determined to be only a surface scratch.

Figure 18 – FPI Hole 2, Surface A (A/C N7545P)
